RE: GEOTECHNICAL INVESTIGATION REPORT FOR NEW RESIDENTIAL CONSTRUCTION AT LOT 10 RIVER MEADOWS SUBDIVISION, TETON COUNTY, WYOMING

GEOTECHNICAL INVESTIGATION REPORT LOT 10 RIVER MEADOWS SUBDIVISION TETON COUNTY, WYOMING

Jorgensen Geotechnical, LLC PO Box 9550 Jackson, Wyoming 83002

May 15, 2015

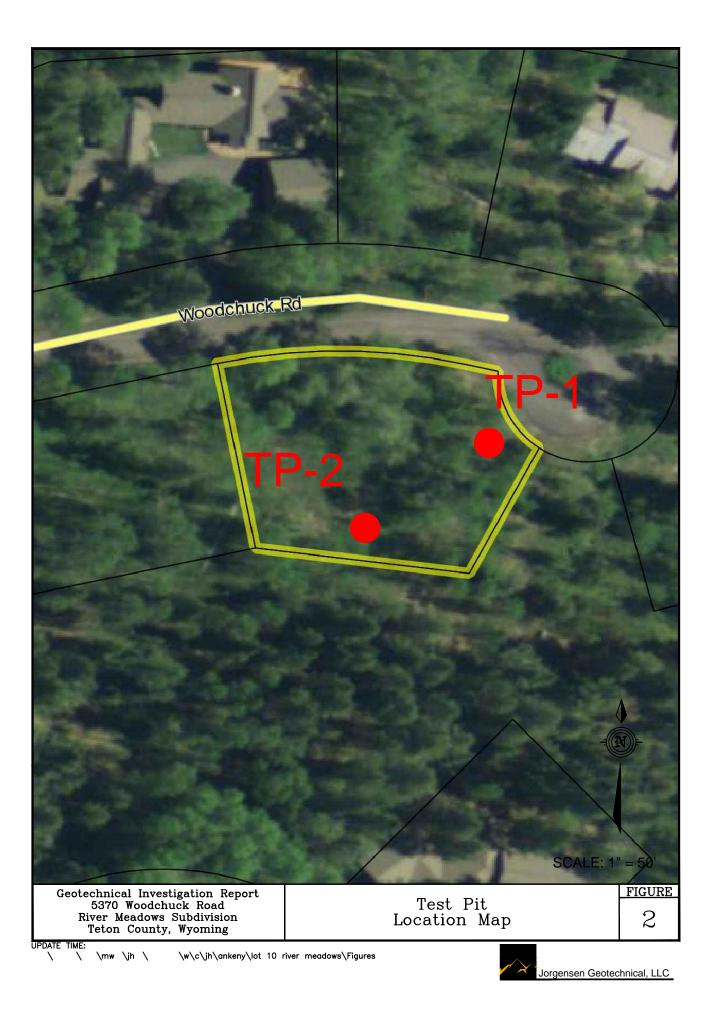
The field investigation was conducted on April 28, 2015. Two test pits were excavated to depths of about 18 and 19 feet below the ground surface (bgs). Excavation of the test pits was terminated at the limits of the excavation equipment. Soil type, thickness, consistency, and relative moisture content were observed and documented by a staff Geotechnical Engineer. Site conditions may vary and actual soil conditions may differ from those represented in the exploration logs. Test pit locations are shown on Figure 2 and test pit logs are presented graphically in Appendix A.

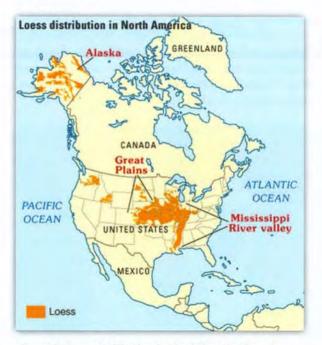
Figure 2. Loess distribution in North America (courtesy of U.S. Geological Survey).

Knowledgeable geotechnical engineers recognize that loess in the U.S. and Europe are Pleistocene deposits cemented by clay, rather than calcium carbonate, and refer to these wind-deposited materials as "Eolian" soils. According to the U.S. Geological Survey, loess deposits cover approximately 10 percent of the earth's surface. The major loess deposits that exist in the U.S., China, Russia, Europe, and Argentina are those most commonly cited in geotechnical literature.

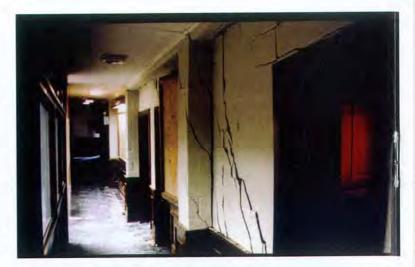
Figure 4. Building damage due to loess collapse.

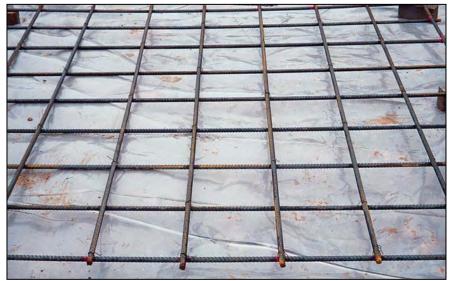
Rebar in concrete slabs placed directly on a vapor retarder help to control slab curling and cracking. Use supported deformed bars no smaller than #4, and space the bars far enough apart so workers can step between them.

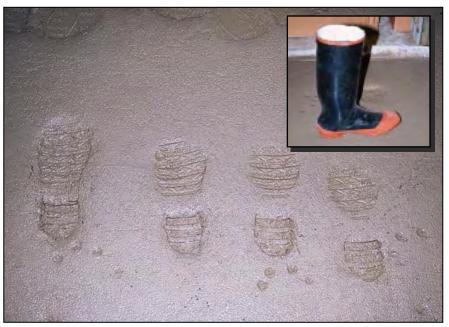
Figure 1. Concrete is generally considered to be ready for floating when finishers leave a ¼-inch-deep footprint in the surface. Using a boot filled with steel shot (inset) to produce footprints, we found that 2½-inch-slump concrete placed on a stone base was ready for floating about 45 minutes earlier than the same concrete placed directly on a vapor retarder.

Base conditions also affect concrete stiffening. In tests performed by The Aberdeen Group, 2½-inchslump concrete was used for two 4x4-foot, 4-inch-thick slabs. One slab was placed directly on a vapor retarder and the other on a crushedstone base. Technicians periodically set a steel-shot-filled rubber boot weighing 75 pounds on the surface and measured the footprint indentation (Fig. 1). Concrete on the stone base had stiffened enough after 90 minutes to allow a ¼-inch footprint

indentation, an indication that floating could begin. Concrete placed directly on the vapor retarder required 45 more minutes of stiffening time before it was ready for floating.
